Town of Eliot Fire Department Energy Assessment Report

2. Project Description

3.1 Introduction:

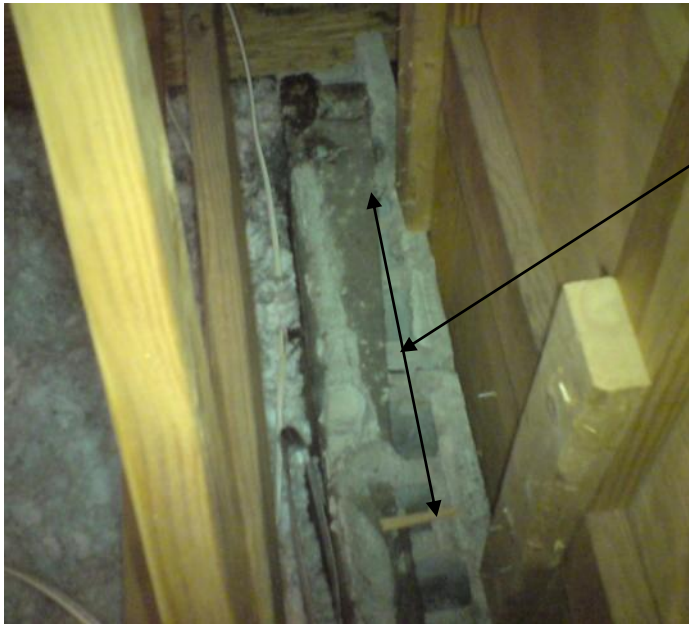
The area between the new and old building has an opening, the tops of the block walls are open, and the gap exists around the kitchen vent, both creating a chimney effect.

View showing top of unsealed & un-insulated block wall creating a chimney affect in the wall

Penetrations, cracks, gaps and voids at the walls and ceilings are recommended to be air sealed. The tops of the block walls, the area around the vent and the opening between the buildings should receive a backer and have 3" of spray foam applied to them. The attic should have new insulation blown into it where the insulation has been disturbed, raising the R- value of the attic/ceiling to an estimated R-38. The rim joist should have the batt insulation removed and where ever accessible the band and rim joists should have 3" of spray foam applied to them to insulate and air seal them.

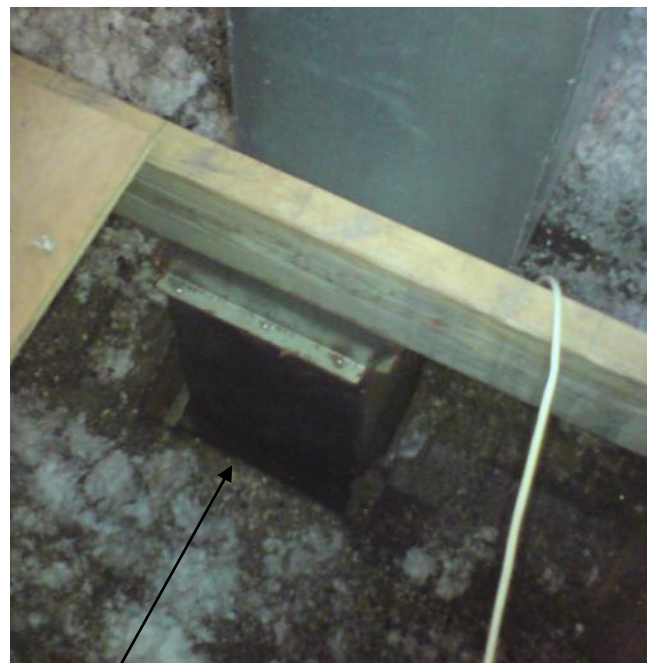
View of heat escaping into attic around gap at vent

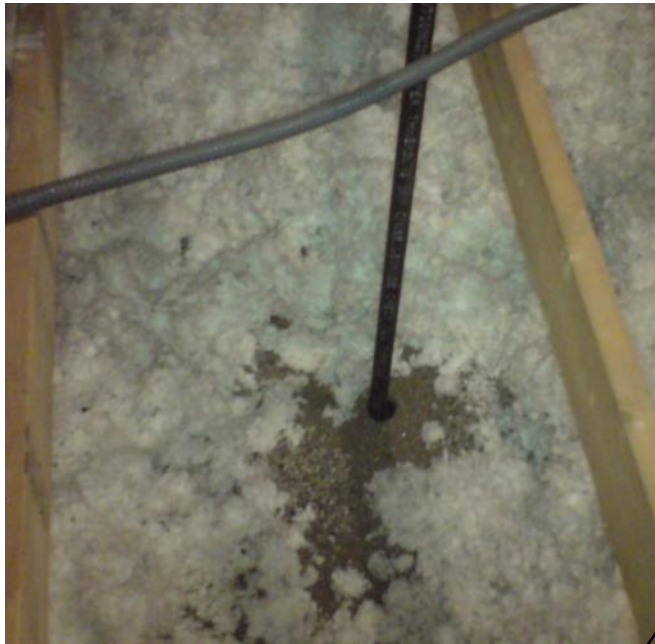
View of area where insulation has been pushed aside showing heat loss (yellow) through thin insulation & around pipe

Penetrations, cracks, gaps and voids at the walls and ceilings are recommended to be air sealed. The attic should have the top layer of insulation removed, the lower layer refitted and 8" of settled cellulose blown into the attic space, raising the R- value of the attic/ceiling to an estimated R-45.

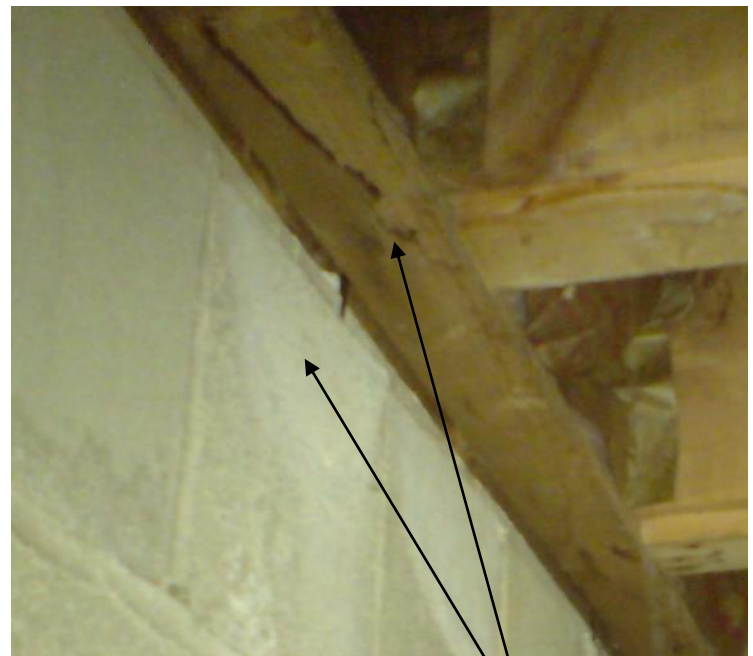
The batt insulation stuffed into the band joist above ceiling does not provide an air barrier and is a poor insulator. The rim joist in the basement has no insulation.

View of band joist showing cold (blue) air infiltration. Note signs of moisture on wall & strapping, likely caused by condensation

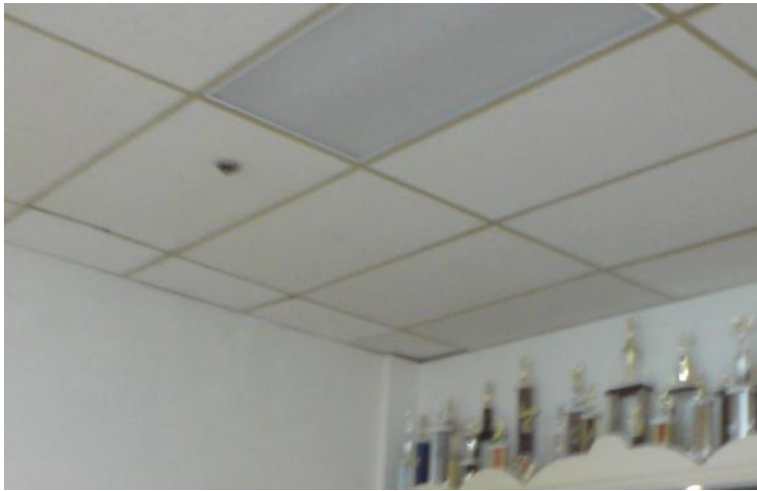
View of meeting room under negative pressure showing cold air infiltration from gaps, voids & penetrations

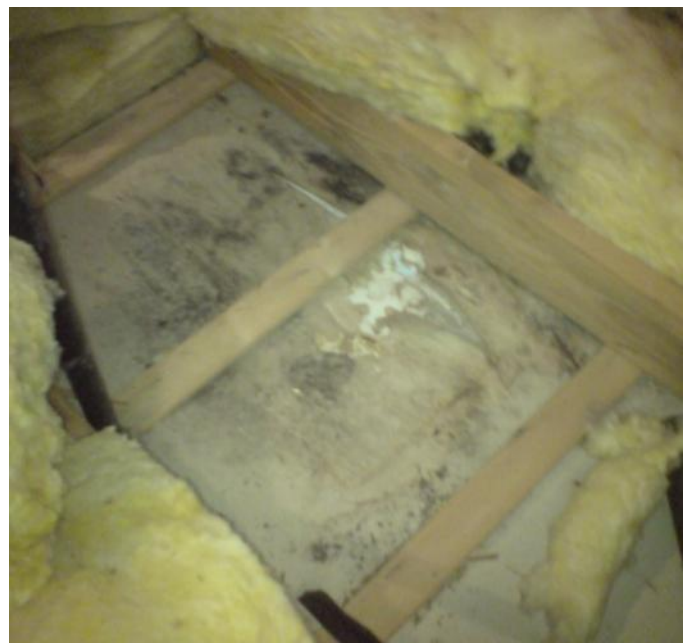
New apparatus bay showing section missing insulation & heat loss

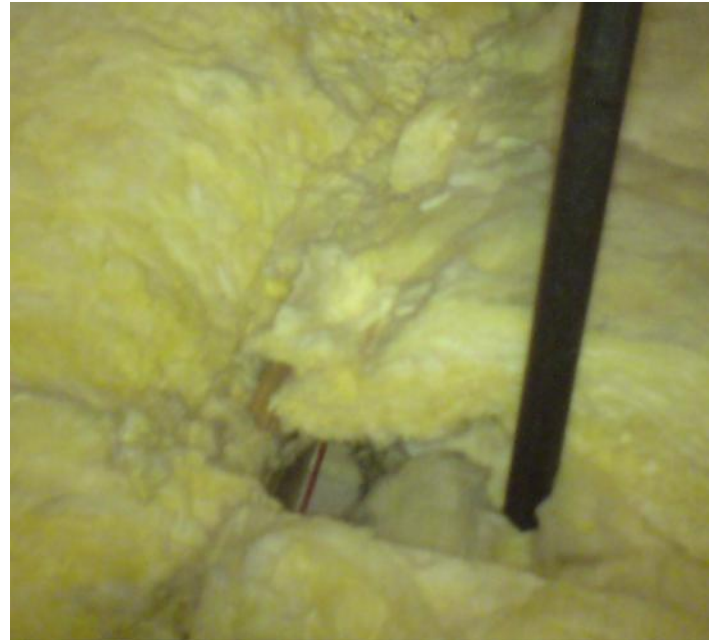
View of penetration showing heat loss in new apparatus bay

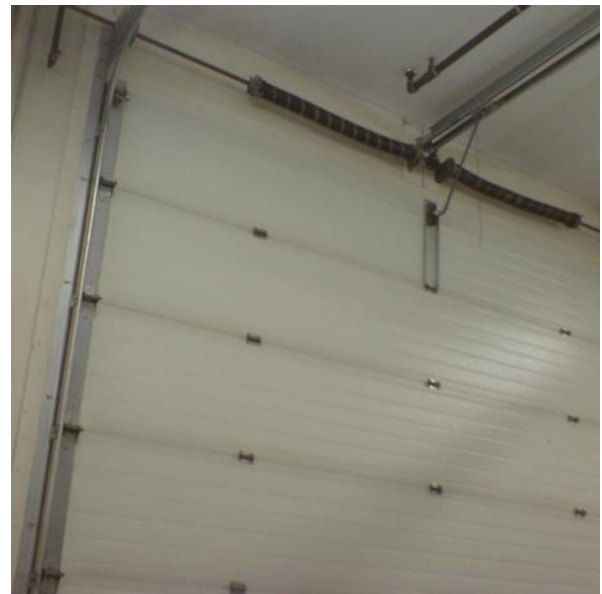
The weather stripping of the overhead doors and man doors are worn and two of the man doors are approaching the end of their useful life. It is recommended that the doors have the weather stripping replaced with a commercial grade material. Replacing the two man doors in the 1995 section of the building should also be considered.

Middle overhead door showing air infiltration at edges

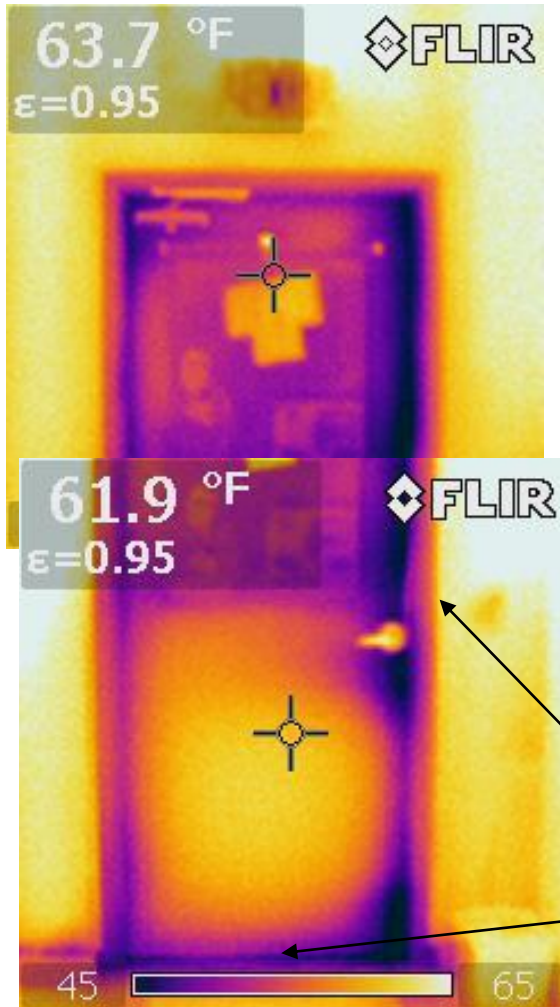
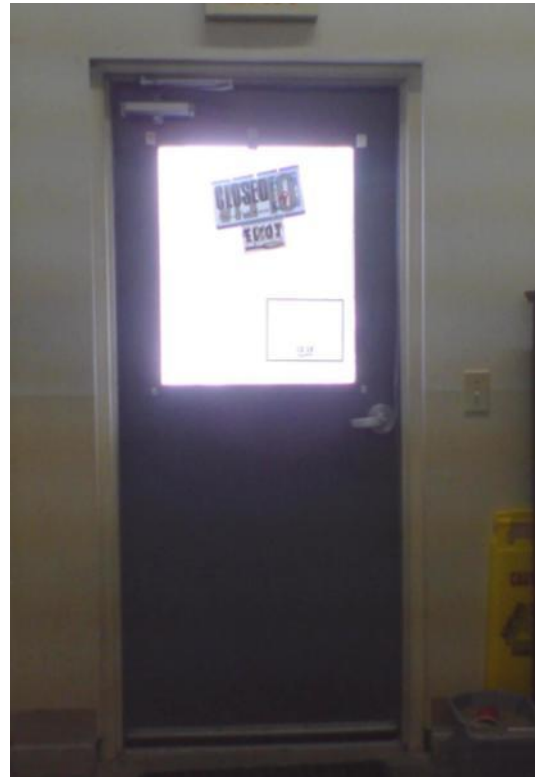
Door at east elevation at new apparatus bay showing air infiltration

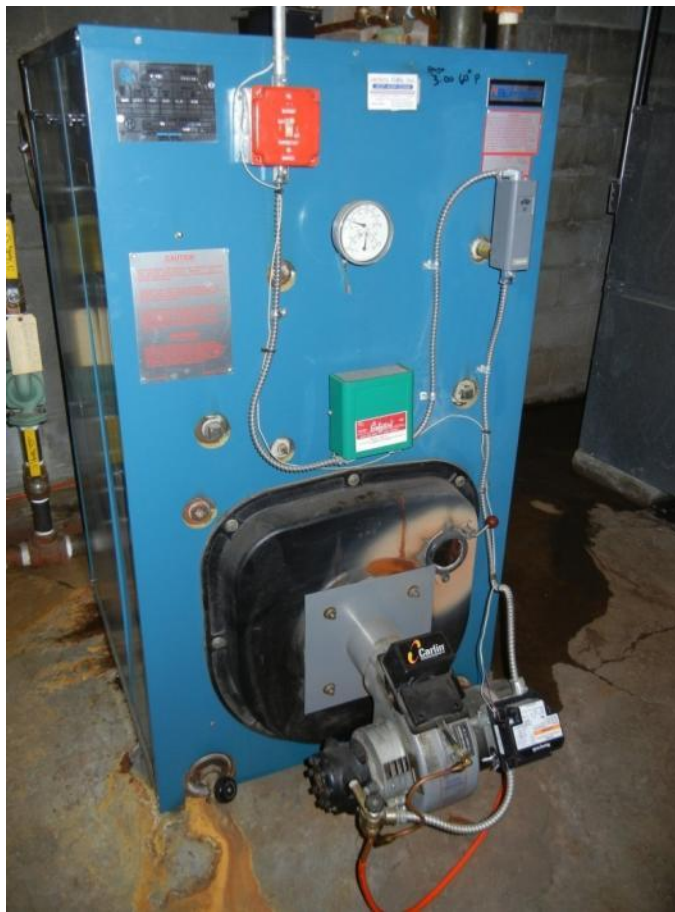
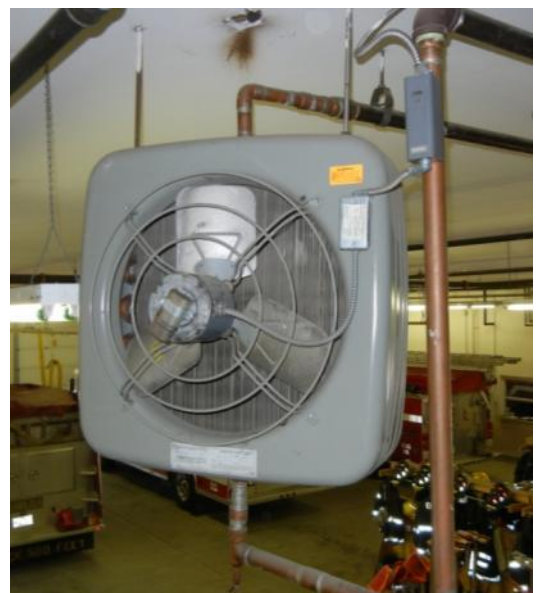
The boiler is 16 years old and approaching the end of its useful life, which is in the 20 to 25 year range. Since, natural gas is not available and propane is not cost effective as compared to oil, oil would still be the recommended fuel. When it comes time to replace the boiler a triple pass oil boiler is recommended and installing two smaller boilers that can be staged is preferred. These measures are estimated to save 5% and 10% to 15% respectively. In the mean time installing an outdoor reset can save an estimated 5% in fuel.

View of boiler & fan powered unit heater

would be lengthy. A more economical approach would be to add another zone in the basement and heat with a fan powered unit heater. Sealing and insulating the duct work in the basement and adding a programmable thermostat in the meeting room is recommended. Also, replacing the floor registers with devices that can better control the air flow and distribute the air more evenly is recommended.

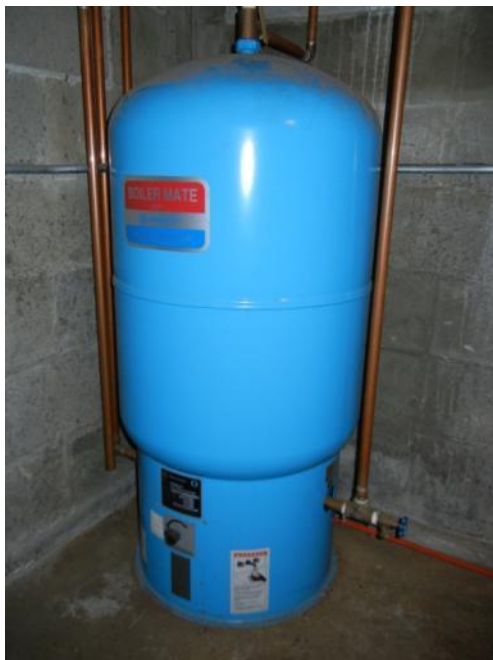
Hot water is provided by an indirect hot water tank from the boiler. However, this causes the boiler to run 7 days per week during the non-heating season and raises the water temperature to 180° for heating rather than the 120° for hot water. It is estimated that 165 gallons of oil is used for hot water during the non-heating season for a cost of \$ 520.

View of 40 gallon Boiler mate indirect hot water tank

Insulating the hot water supply and cold water feed piping in the boiler room is recommended.

Based on the usage and projected cost savings it is recommended that the indirect hot water tank on the boiler be replaced with a propane fired 7 gpm tankless hot water heater.
